SOIL EROSION SERVICE

Bethany, Missouri.

Name Mr. Paul B. Strickler.

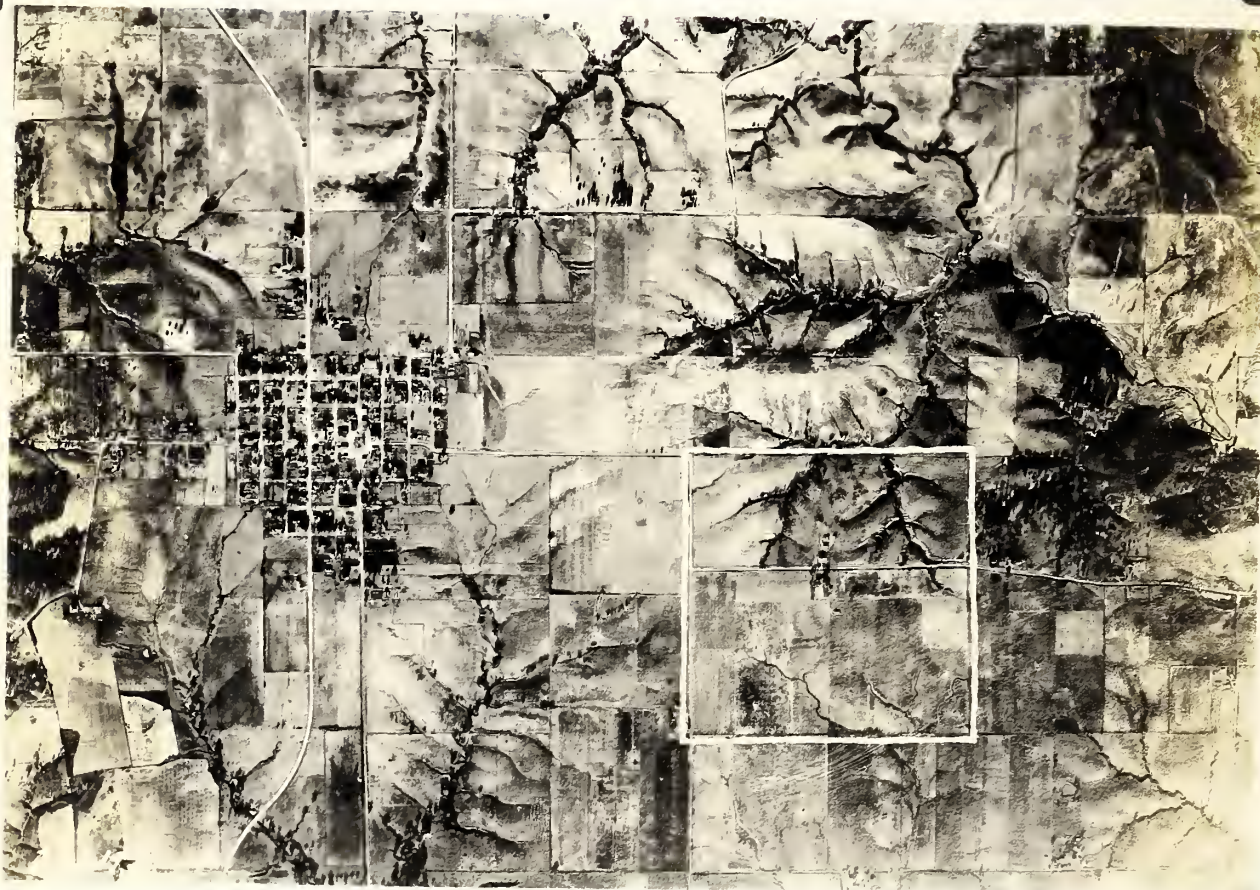
Air plane view of farm vicinity of Eagleville. Base map  
is on opposite page.

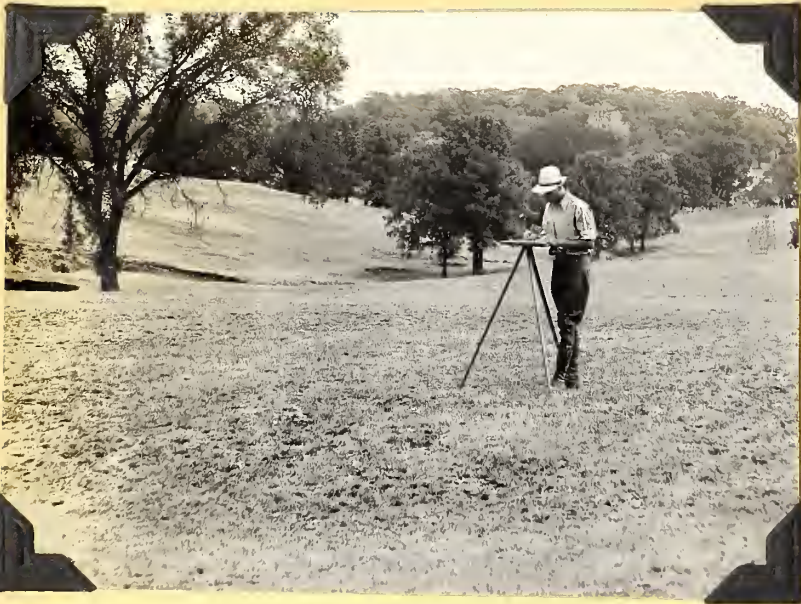
# MAPPING

-----Making base map  
with plane table.

Getting the slope  
of the land. -----

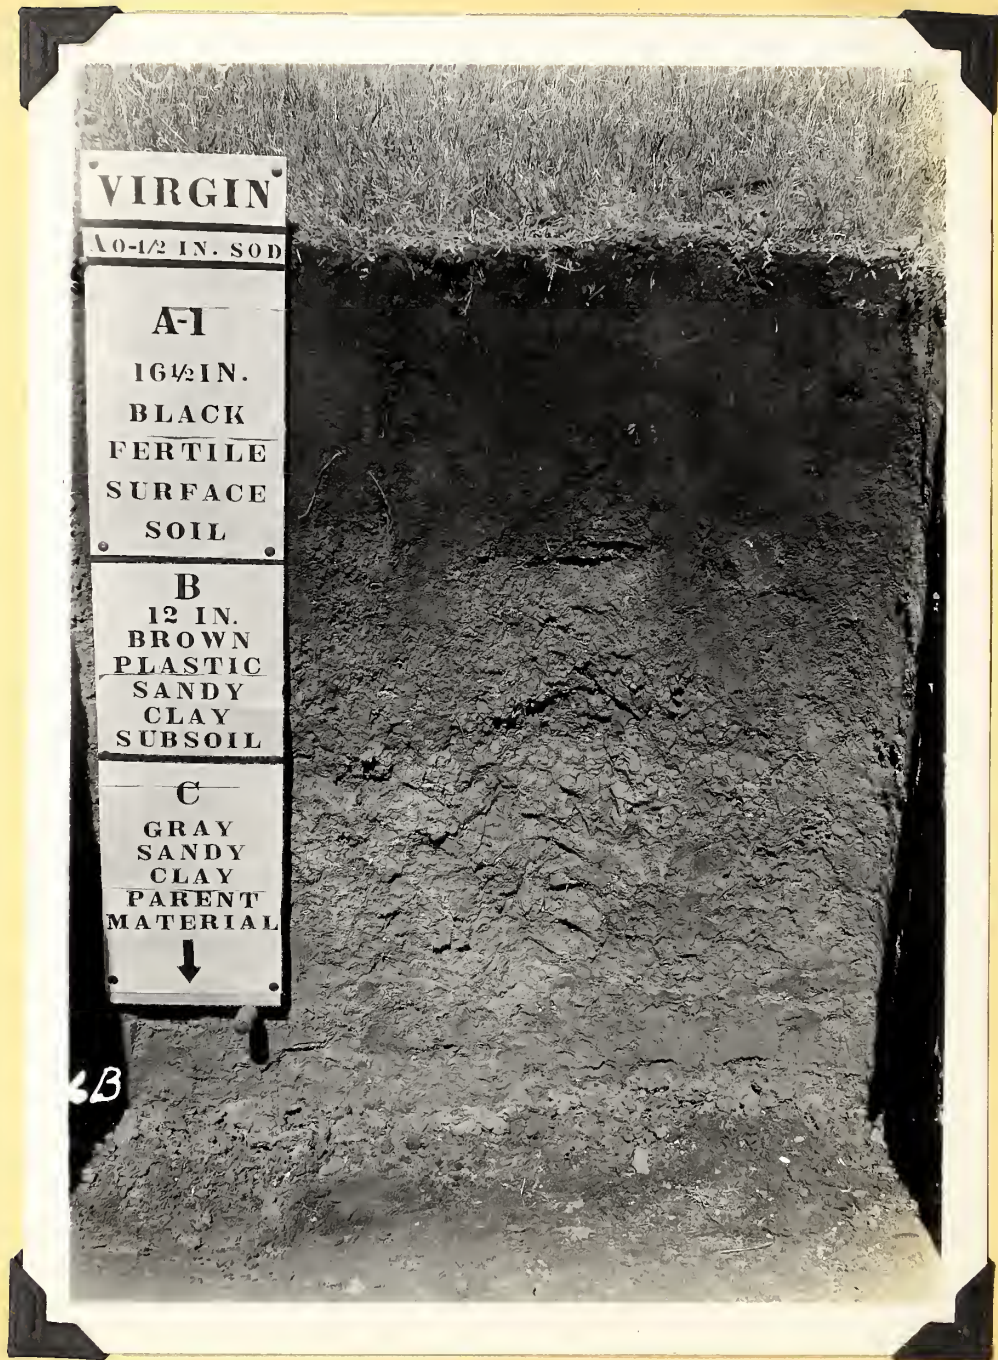
SOIL PROFILE

Our heritage of virgin soil - - - - -

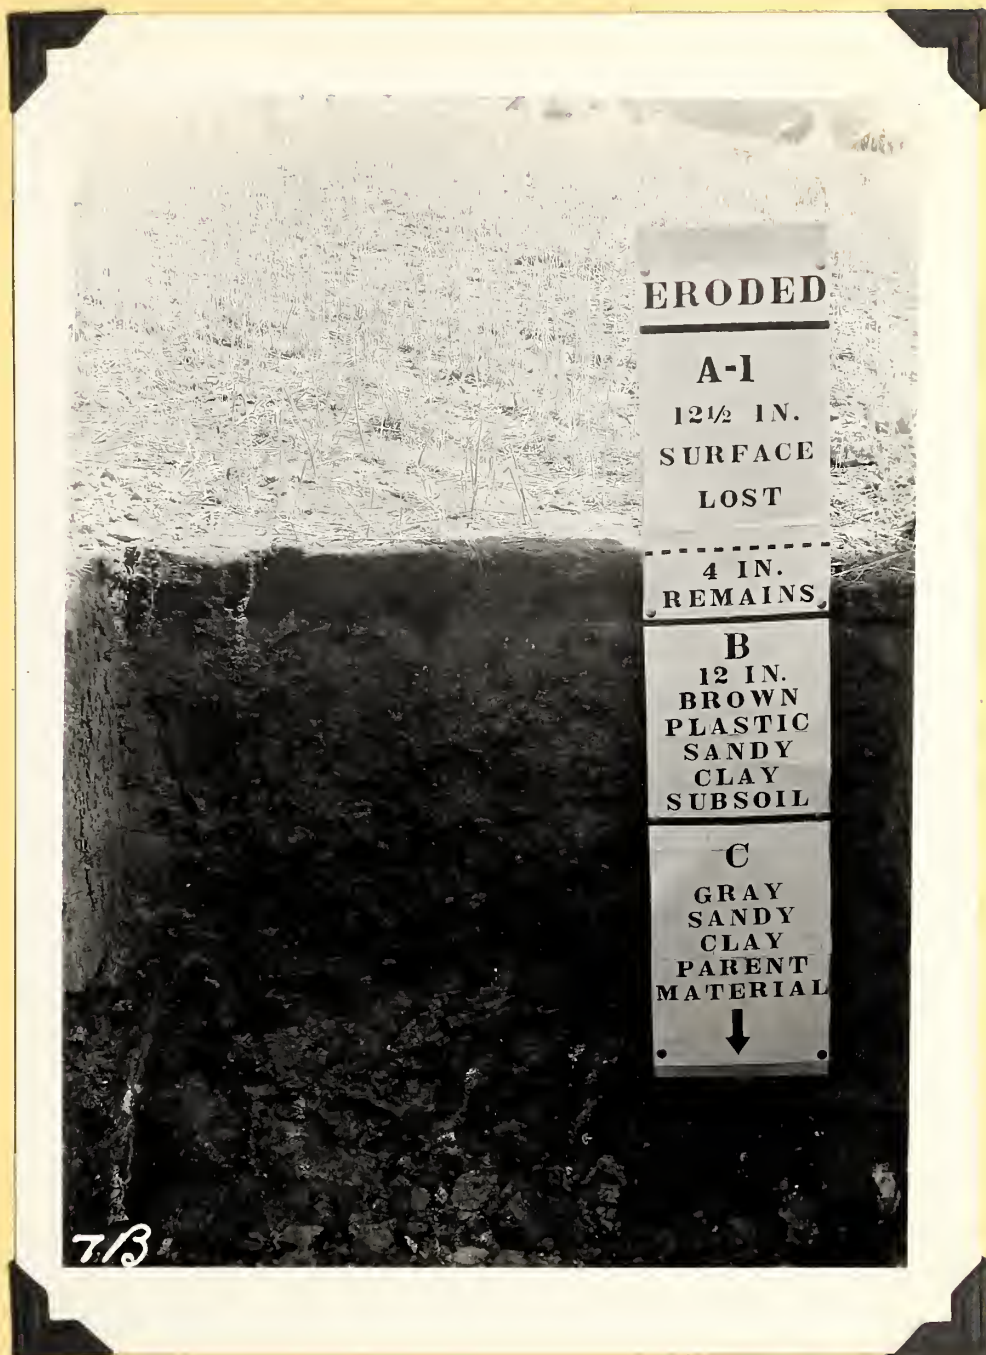
SOIL PROFILE

-----next generation heritage of poorhouse soil.

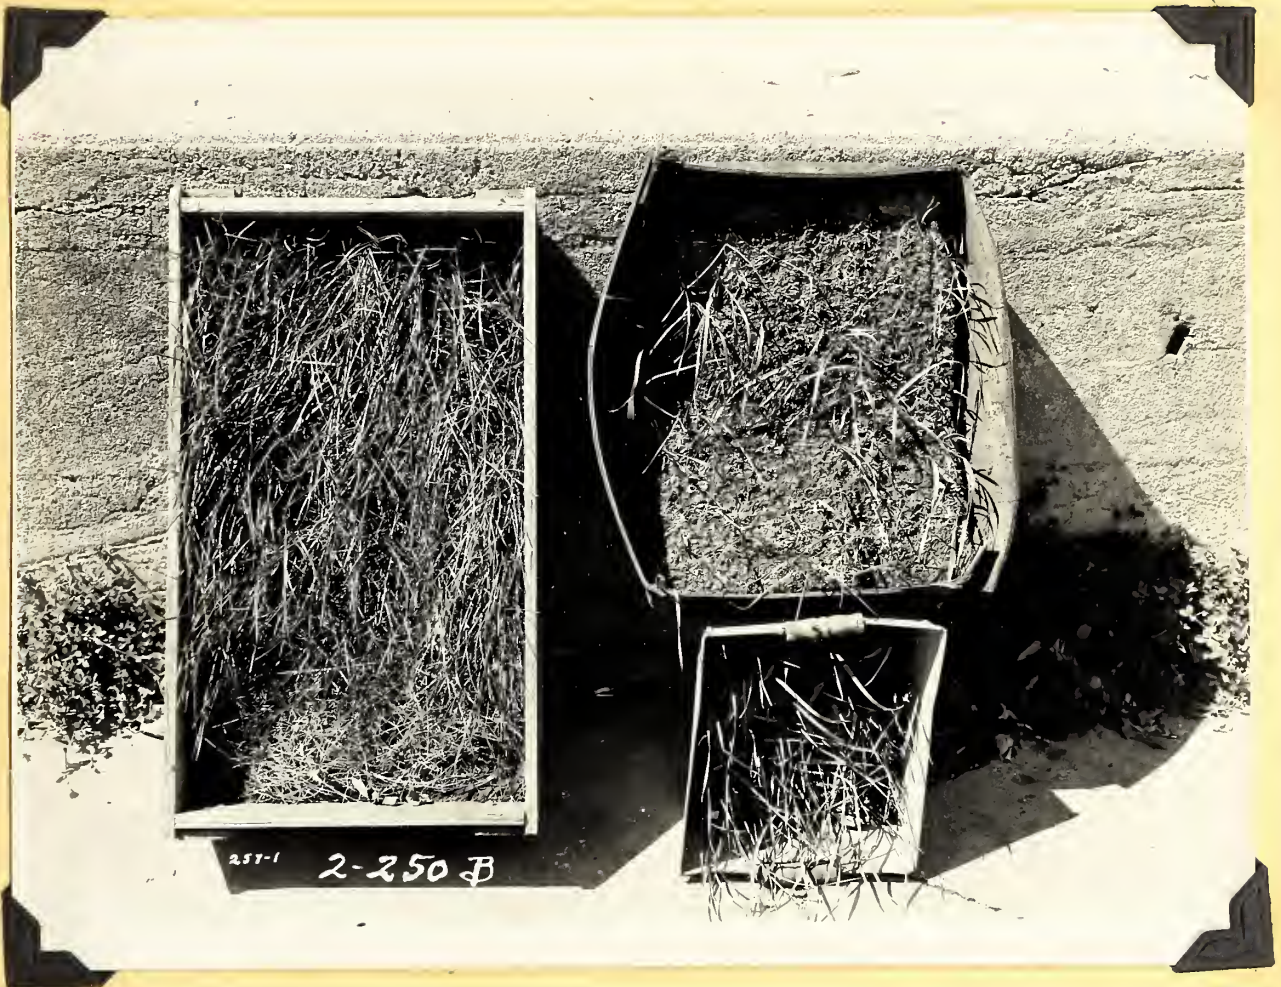
THE EFFECT OF DROUGHT ON PASTURE GRASS  
UNDER DIFFERENT DEGREES OF GRAZING

Left hand--Sod lightly grazed. 100% recovery

Top right- Sod taken from Lars Leetun farm closely grazed by sheep. Bluegrass 90% dead. Scattering growth surviving is quack grass.

Lower right--Medium heavy grazing, about 50% recovery.

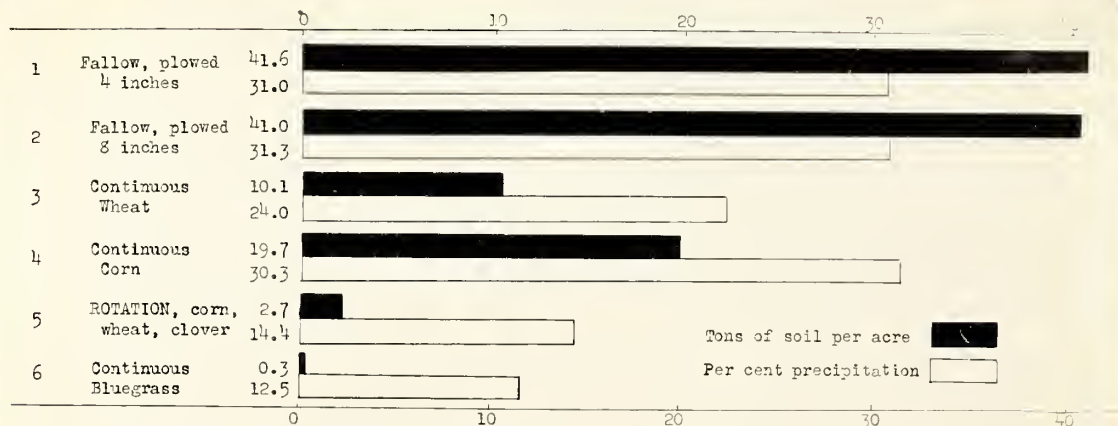
Graph 3  
AVERAGE ANNUAL SOIL AND WATER LOSSES, 1918-31, inclusive

Shelby loam, slope 3.68 per cent; mean precipitation, 40.37 inches  
Plots 1 to 6 inclusive, 6x90.75 ft.

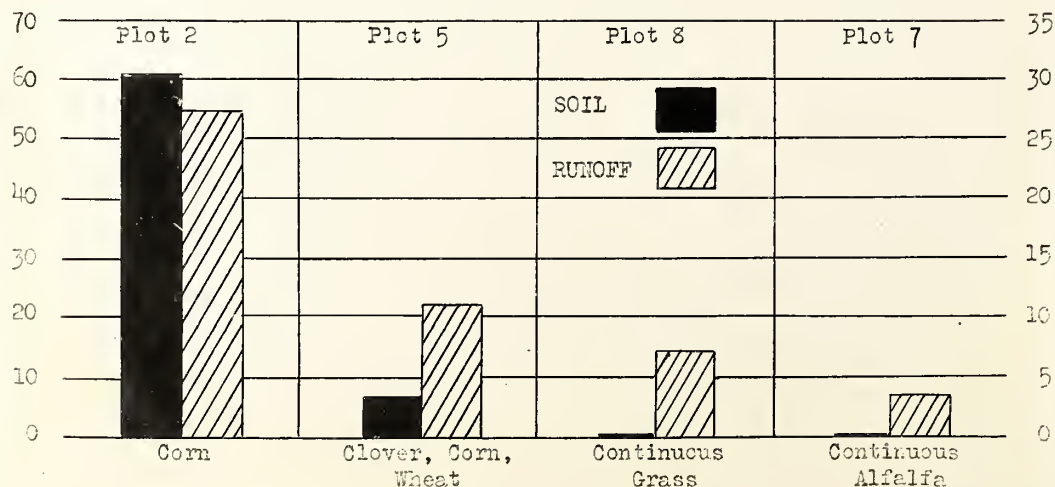
## EFFECT OF CROPPING SYSTEM ON SOIL AND WATER LOSS

Source: Bethany Soil Erosion Experiment Station

Average annual losses for years 1931-2-3

Mean precipitation 33.54 inches

Note: Tentative results indicate that the increased vegetative growth of crops in rotation caused by the addition of lime and fertilizer to Shelby loam reduces soil and water losses.

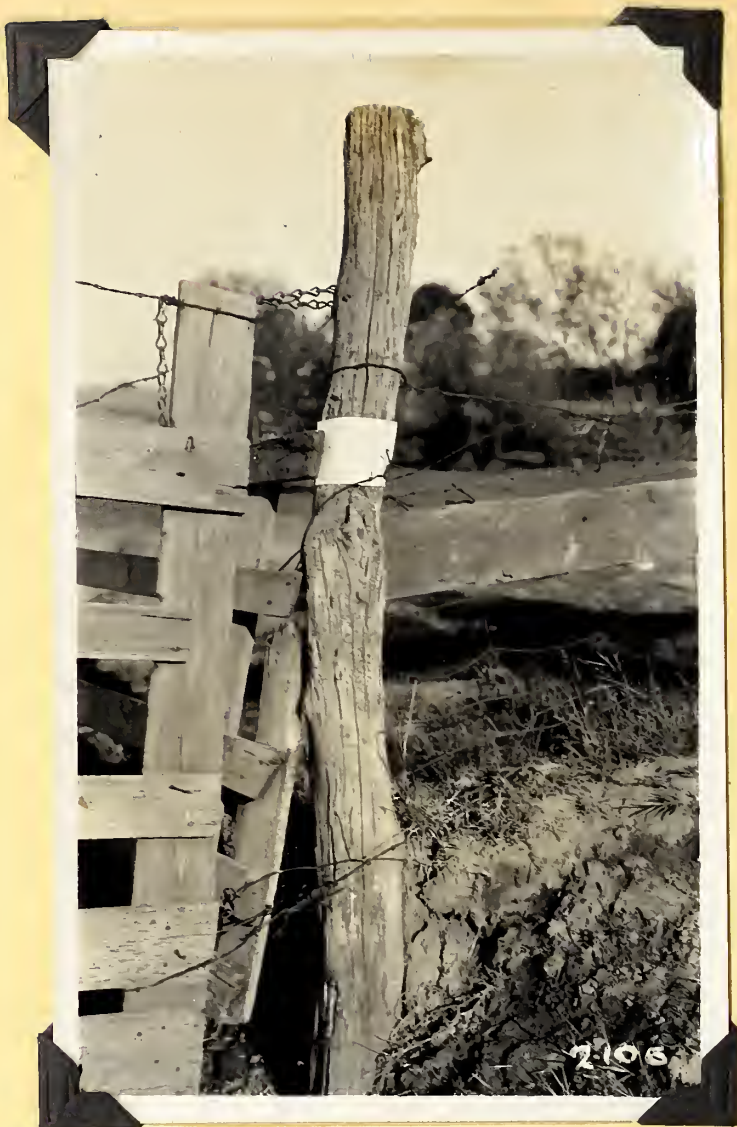
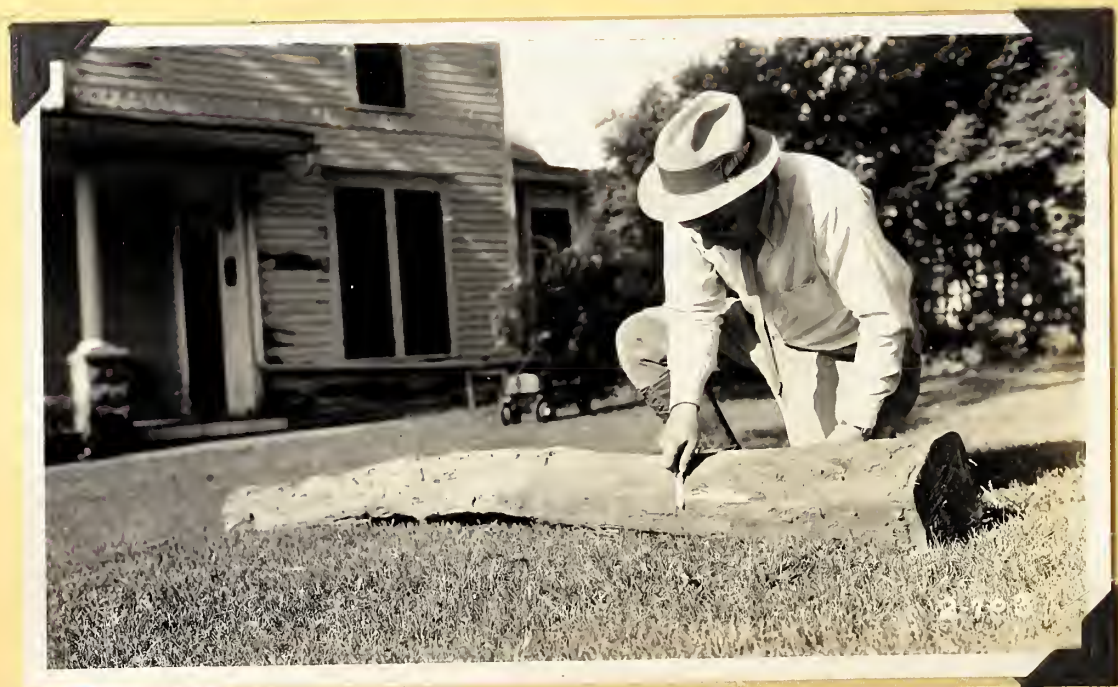
BLACK LOCUST POST SET  
IN THE LOCATION SHOWN  
ON THE HENRY RHINEHART  
FARM IN 1901. POST  
13 YEARS OLD WHEN CUT.

SAME POST AS ABOVE SHOWING SOUND CONDITION AFTER 33 YEARS IN THE GROUND.

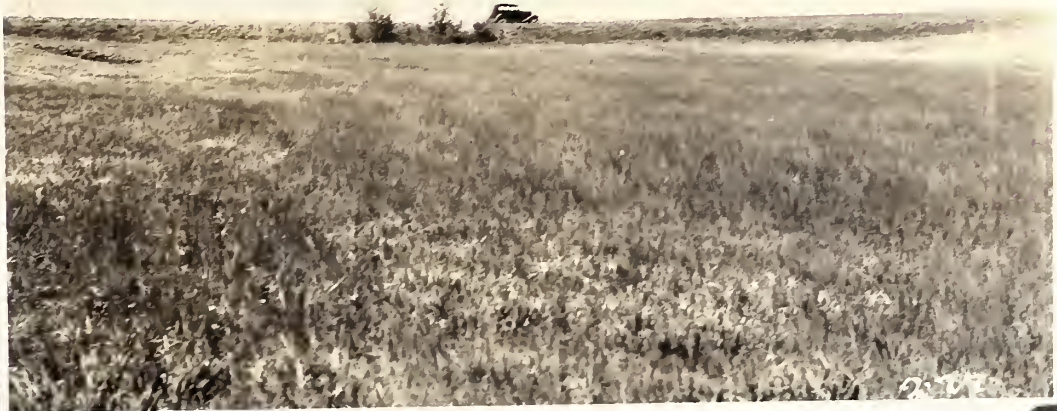
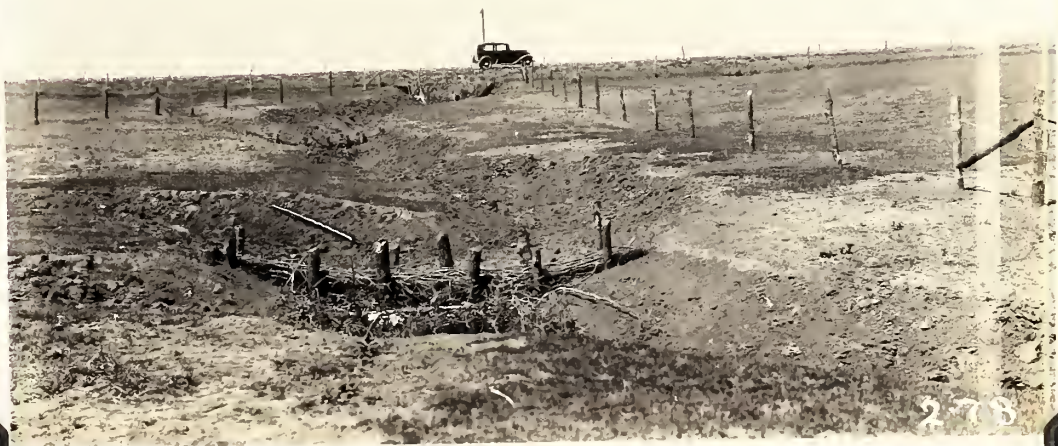
SIMILAR WATERWAYS, SEC. 1-65-27, HARRISON CO., MO.

UPPER WATERWAY NEVER PLOWED

LOWER SHOWS ATTEMPT TO CONTROL EVIL EFFECTS OF PLOWING AND OVER CRAZING

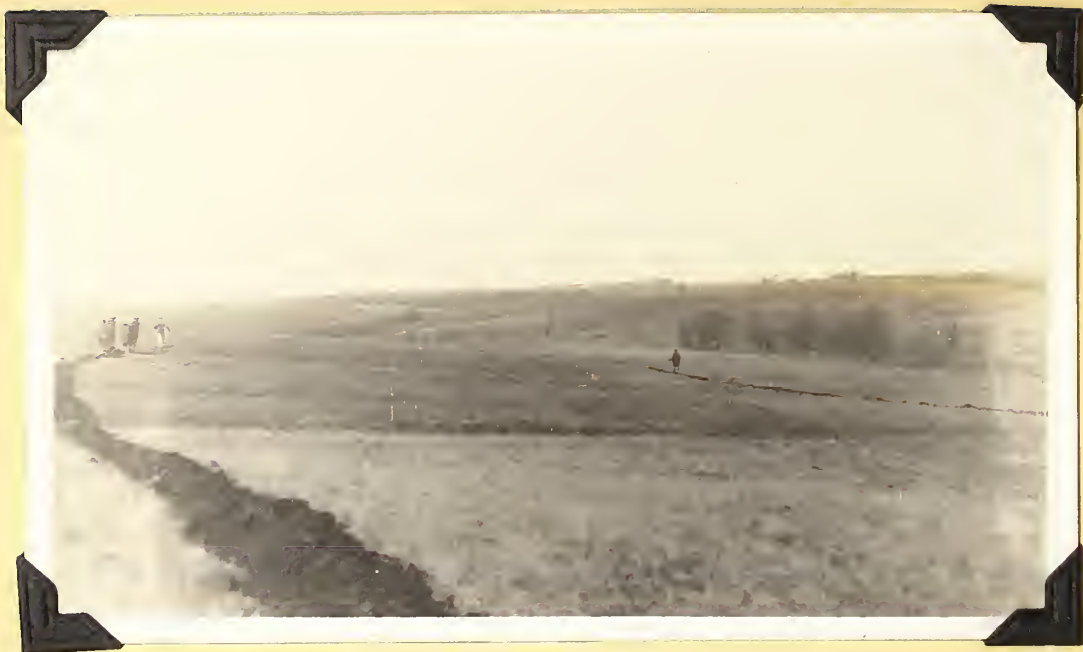
STRIP-CROPPING SET-UP  
EROSION FARM, BETHANY, MISSOURI.

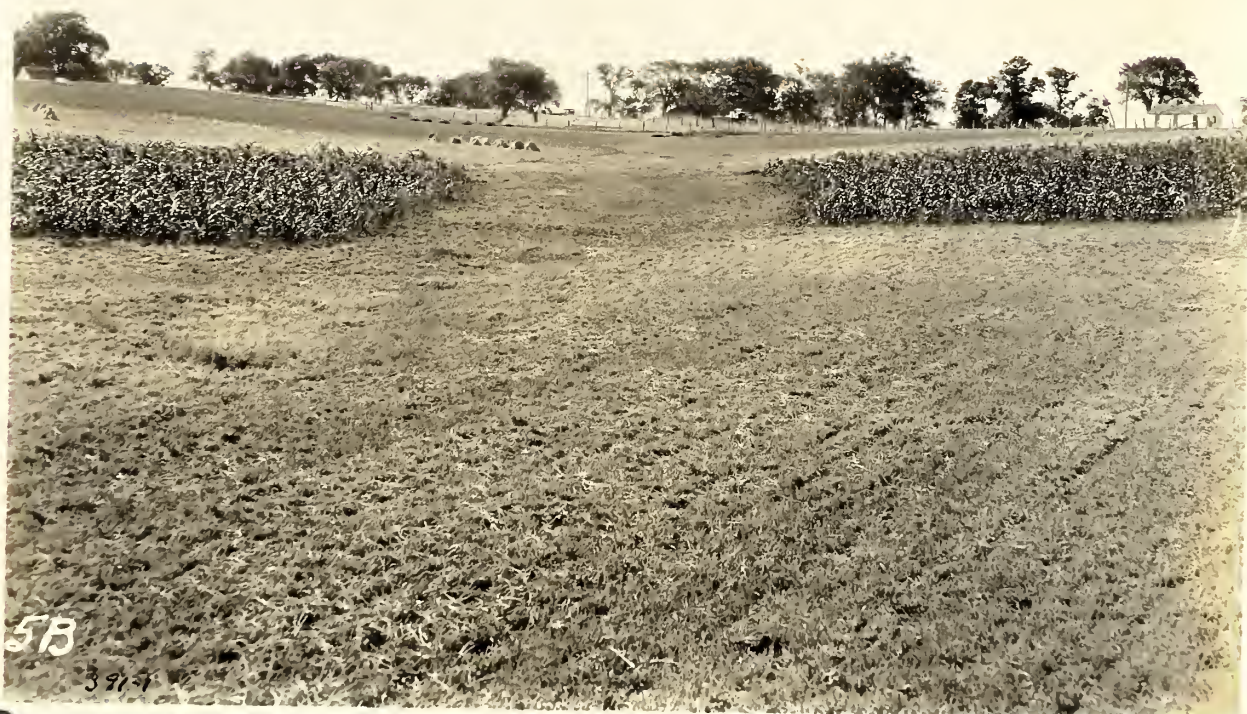
Illustrating the establishment of waterway by sod bags. (Note ridges in waterway.) Clover in foreground, corn in center, oats and clover in background, and alfalfa in extreme background.

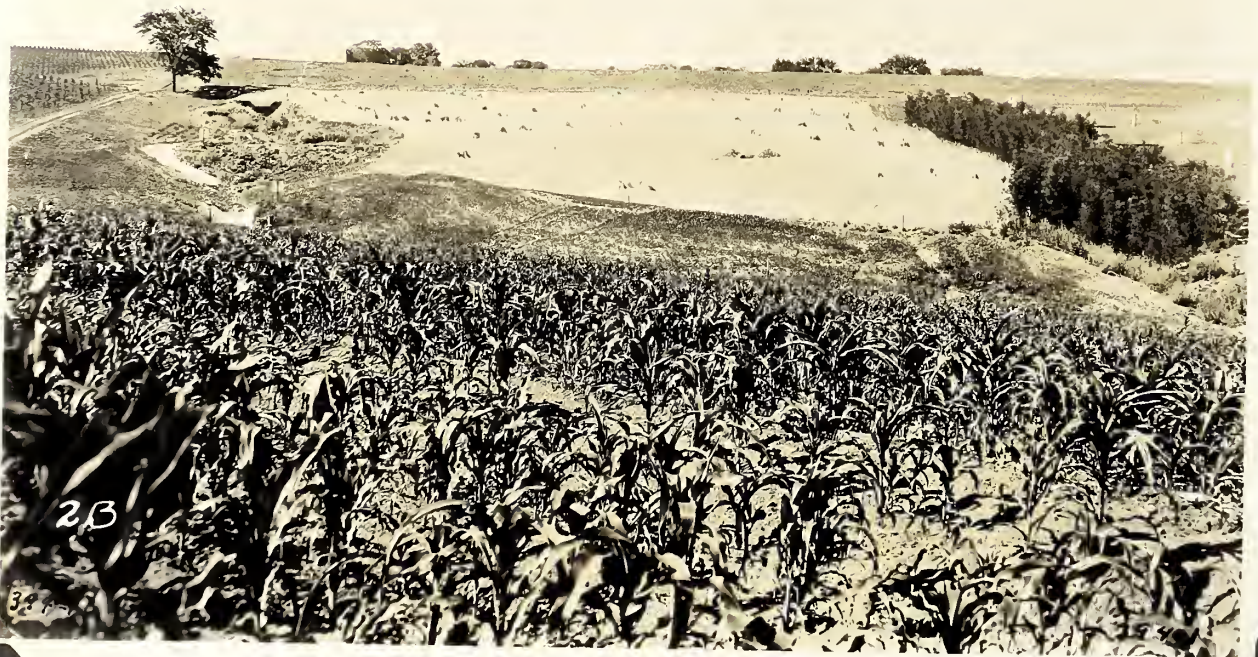
"TWIN GULLIES" ON EROSION FARM, BETHANY.

Similar gullies illustrating two methods of control. The one to the right planted to black locusts and grass; the left hand gully has an earth fill, concrete spillway, showing center field from which 4 inch soil profile was taken.

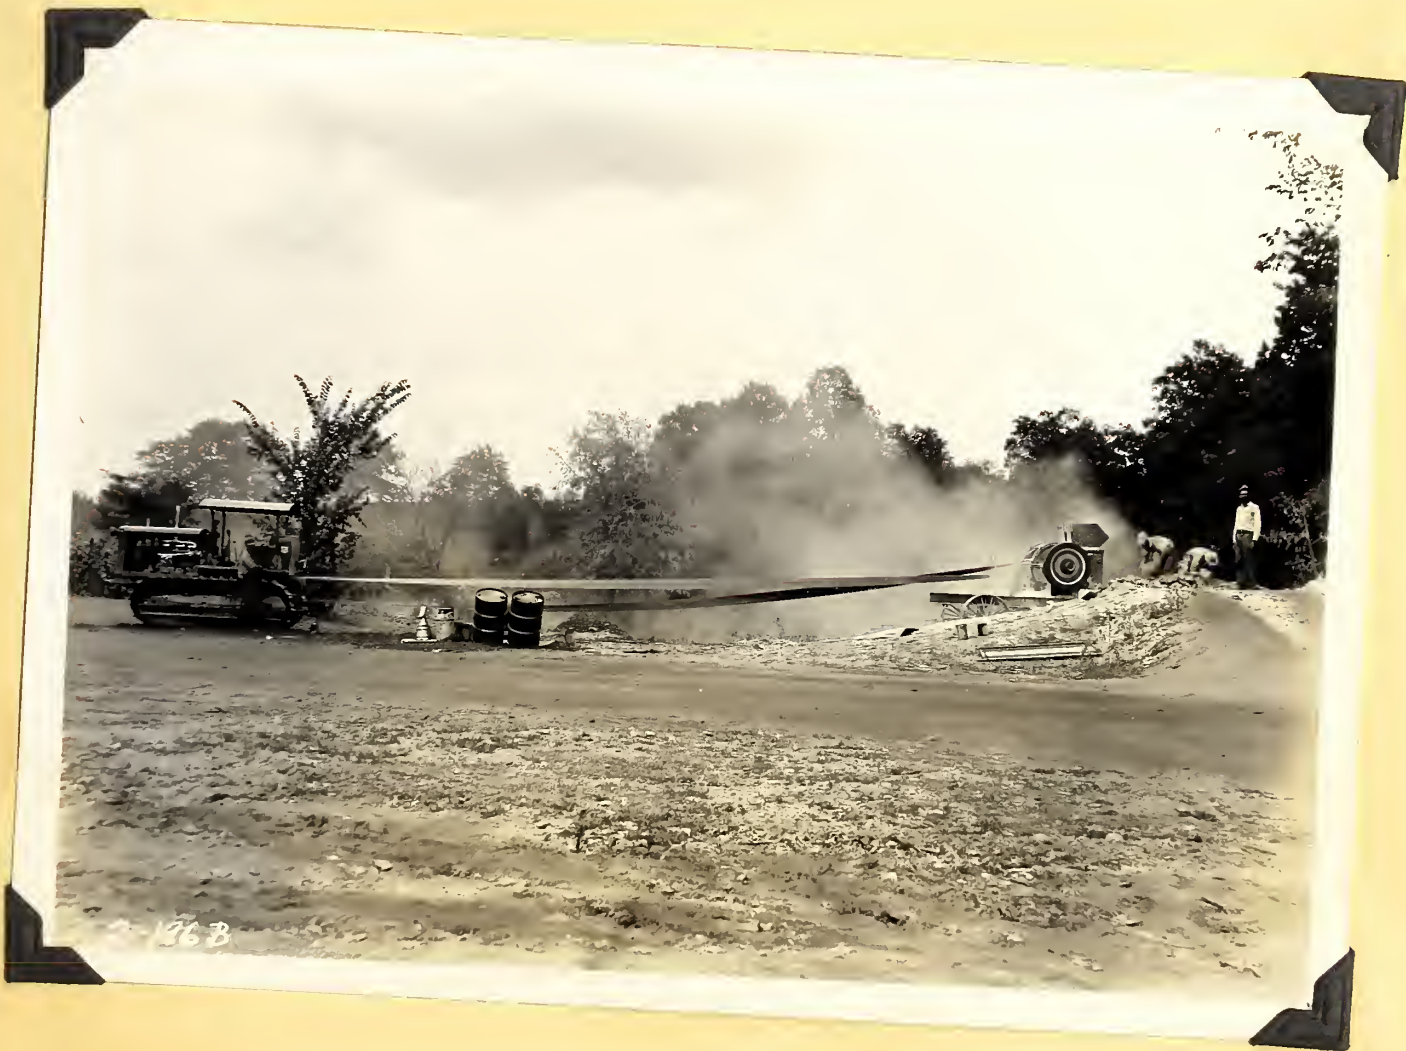
Portable limestone pulverizer in operation.

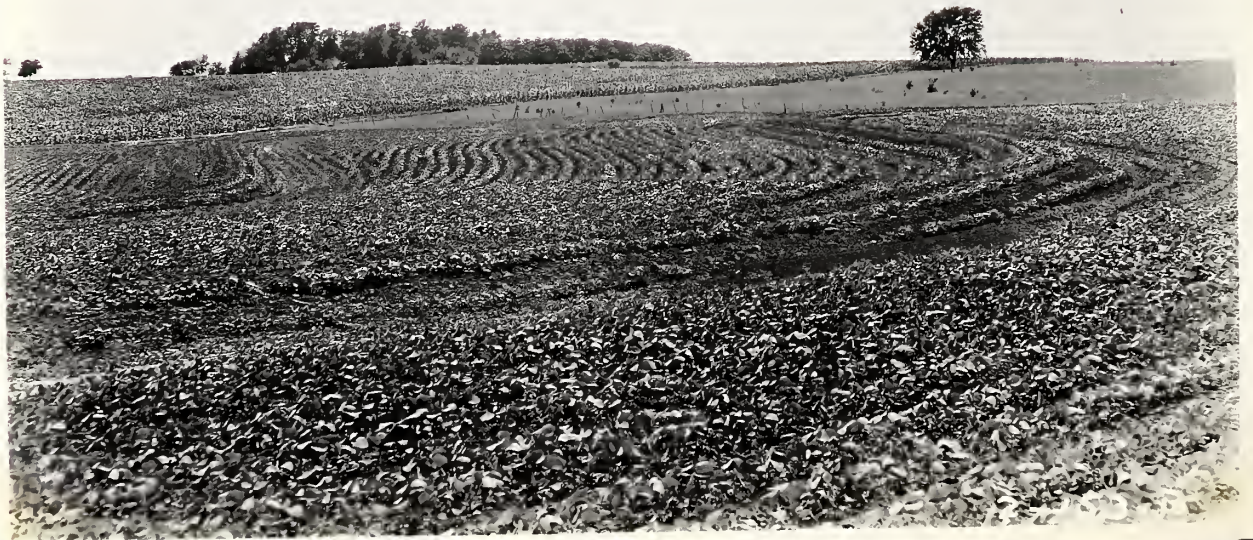
CONTOUR FARMING

Farming with the hill helps stop erosion.

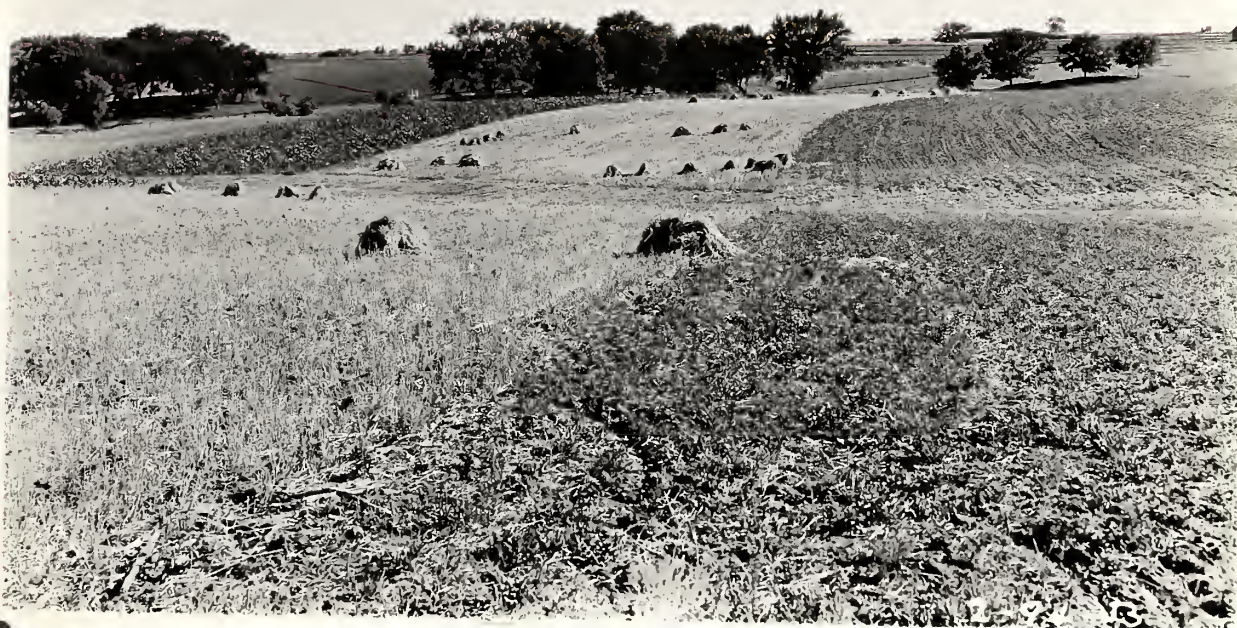
STRIP CROPPING

Strips on the contour breaks the force of water  
and reduces soil erosion.

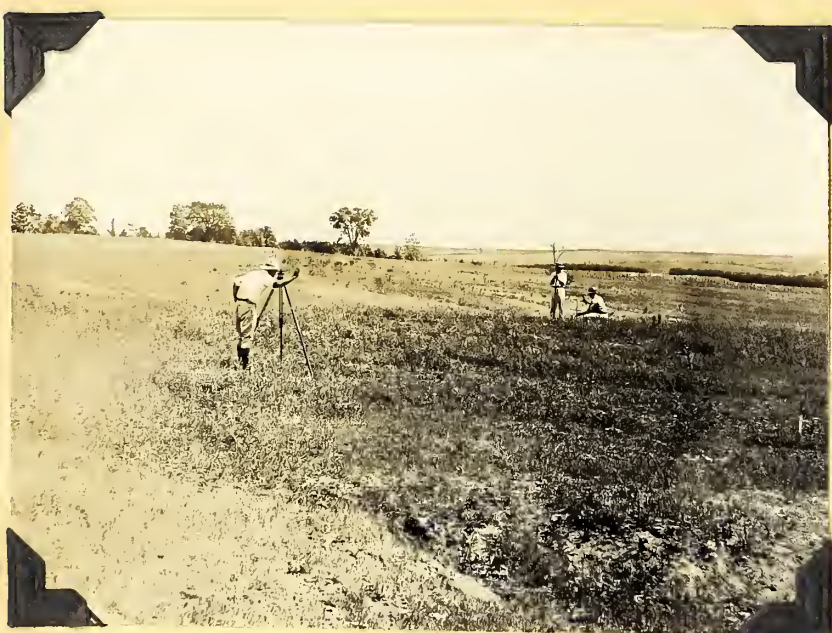
-----Laying out a terrace.

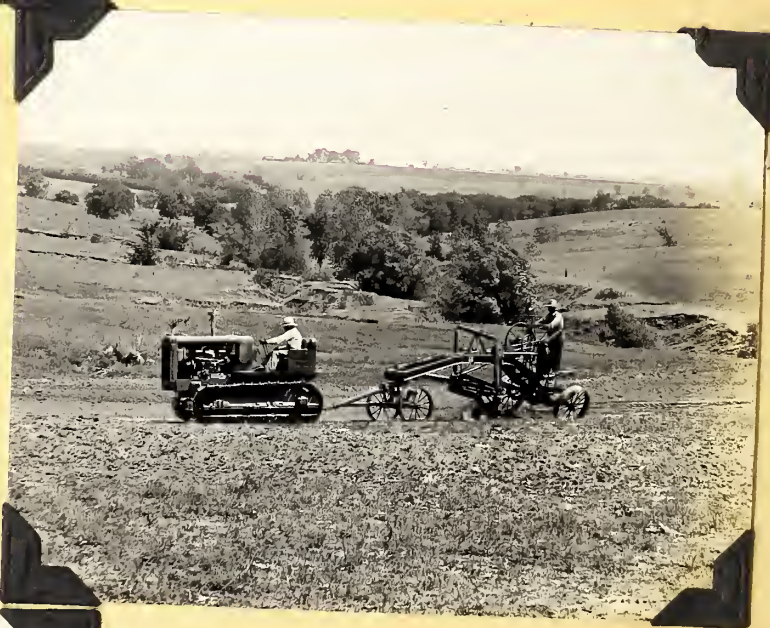
Building terrace-----

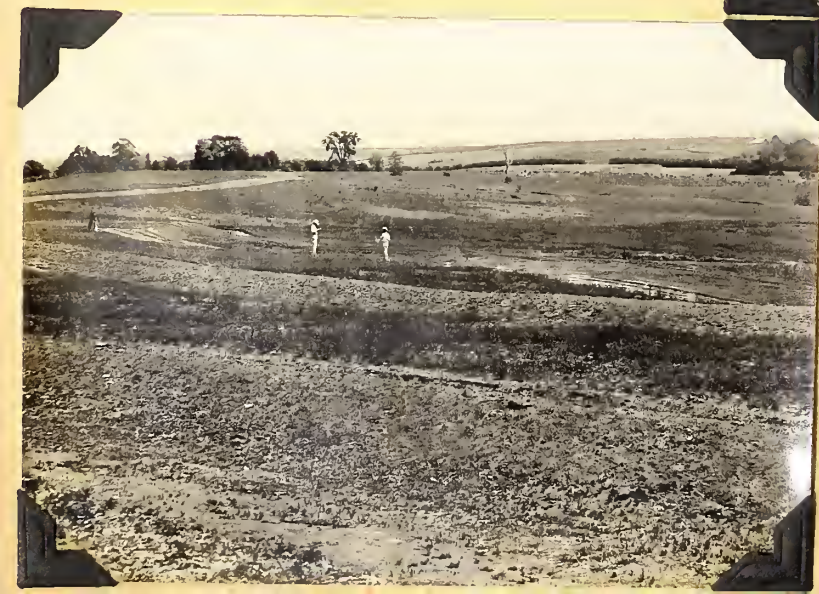
-----Checking a terrace.

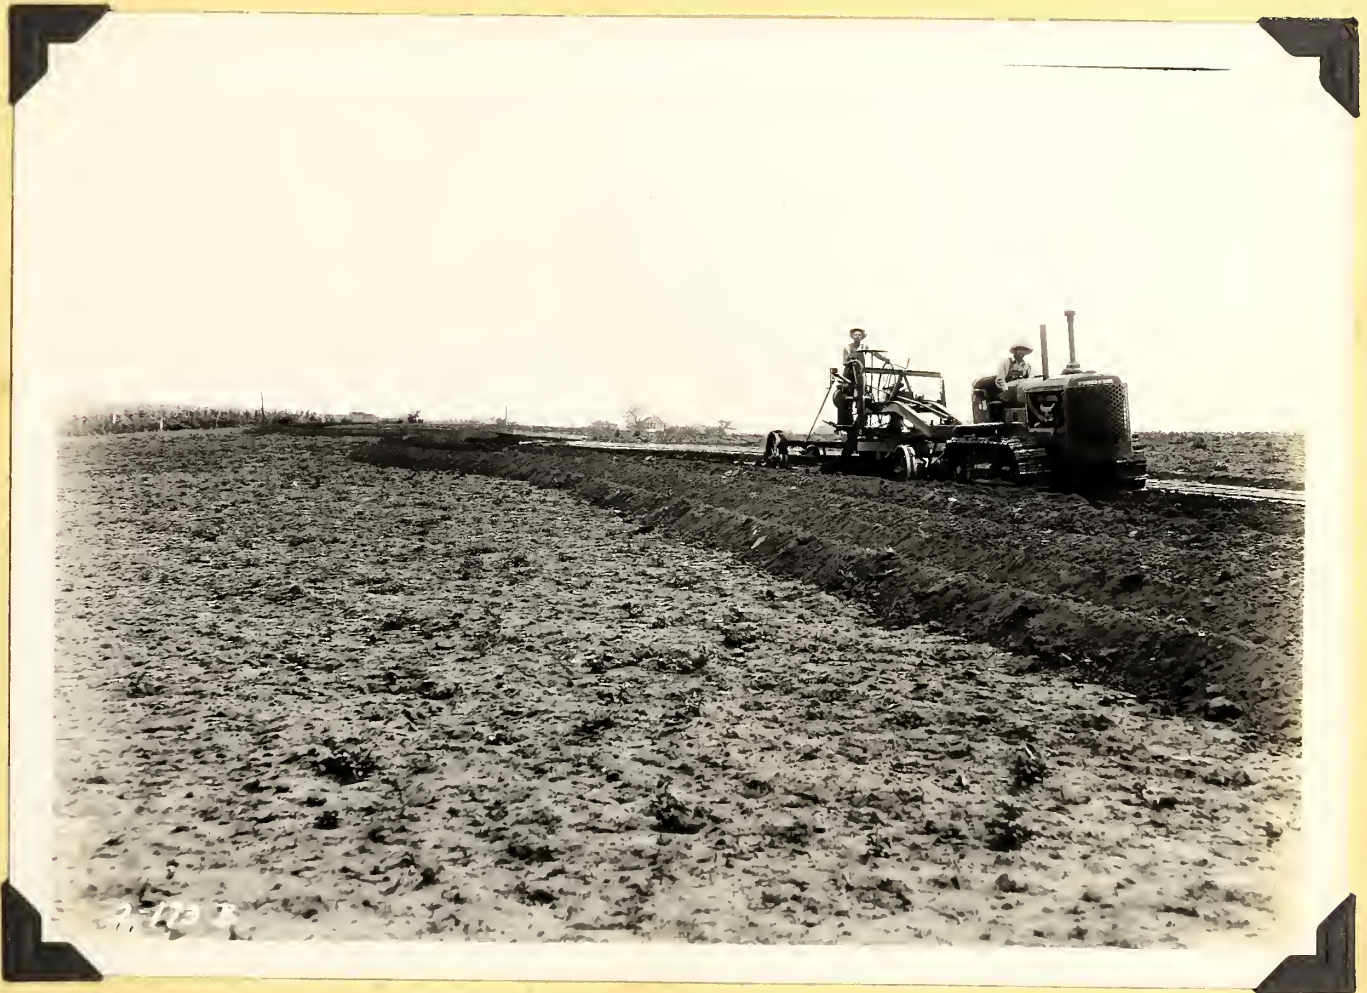
Soil Erosion Service equipment used in  
terrace building.

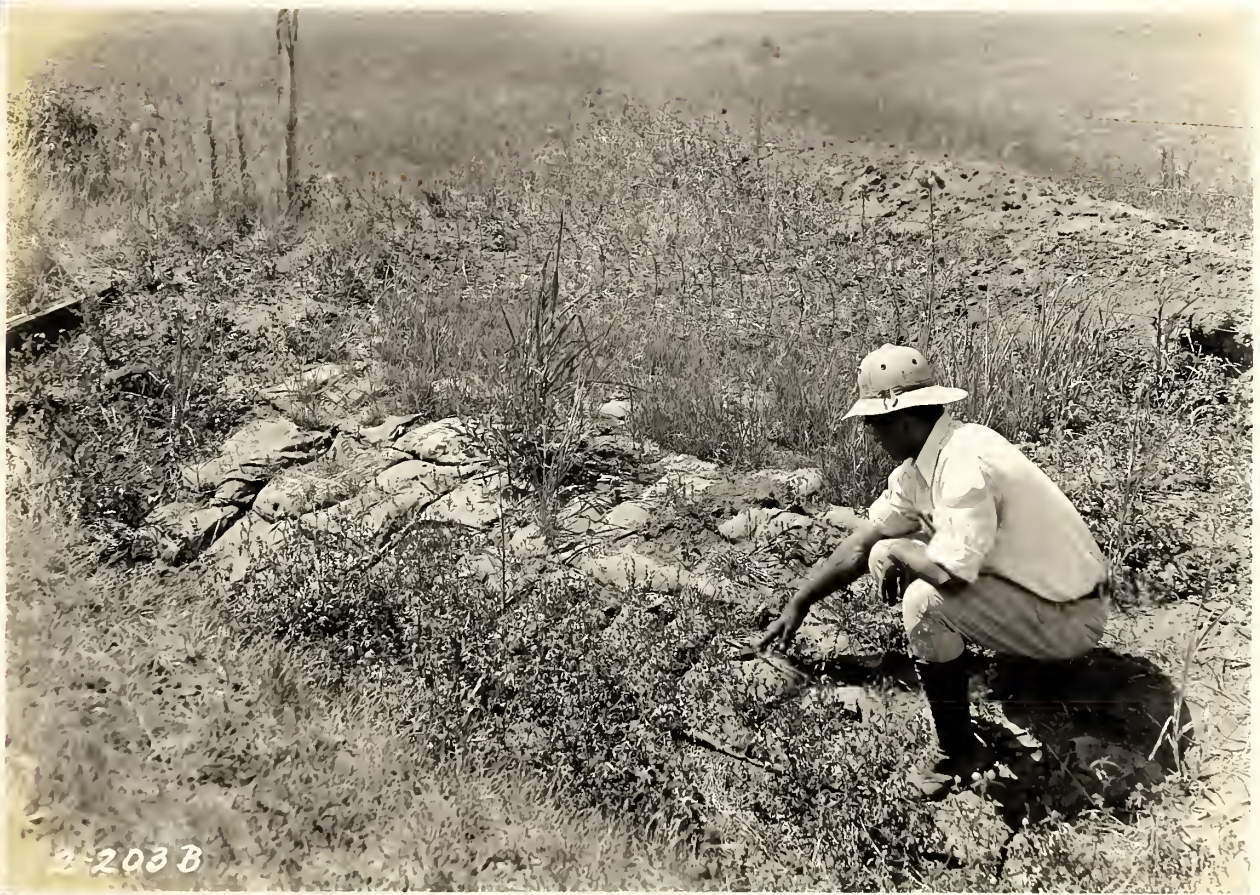
Terrace outlet protected by sod bags.

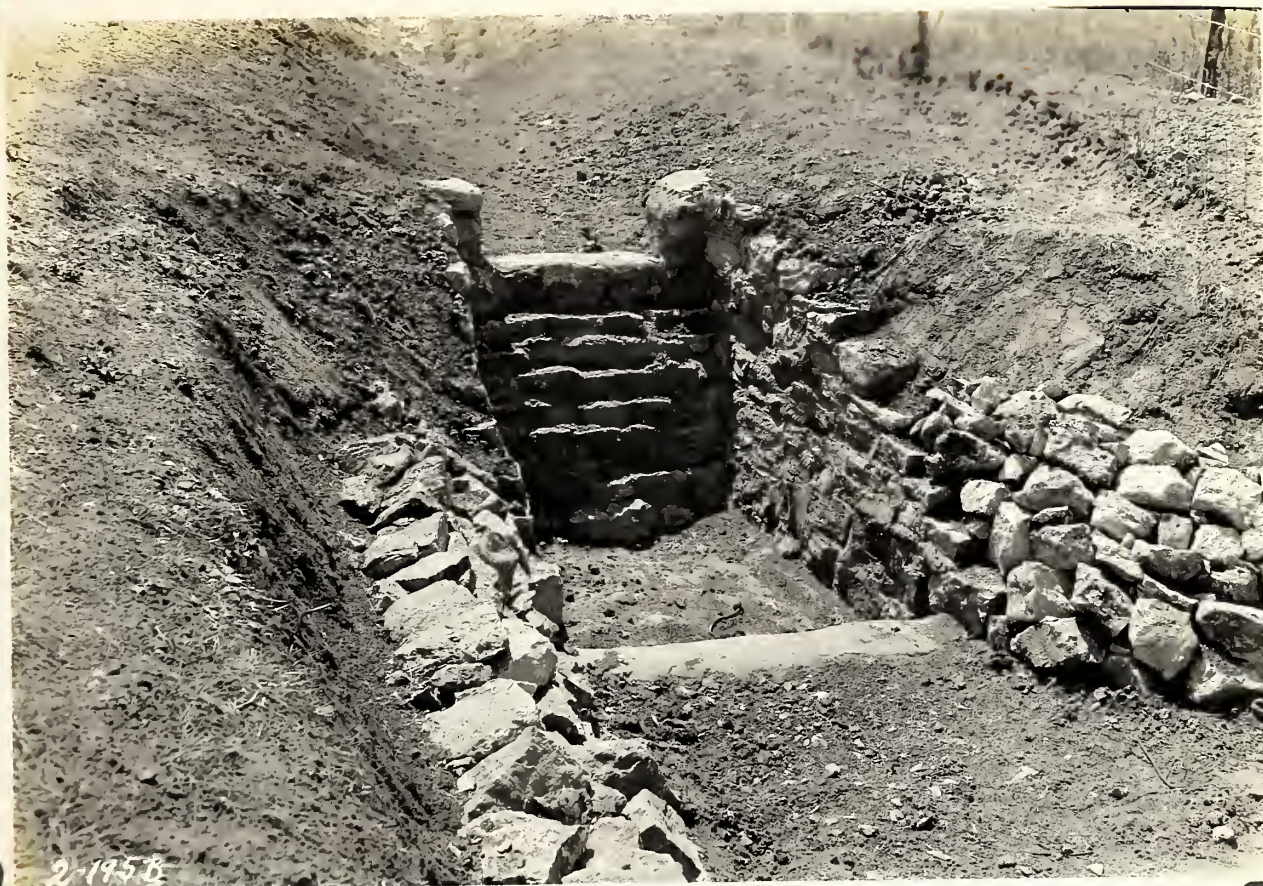
Header dam to protect highway drainage ditch from  
terrace water.

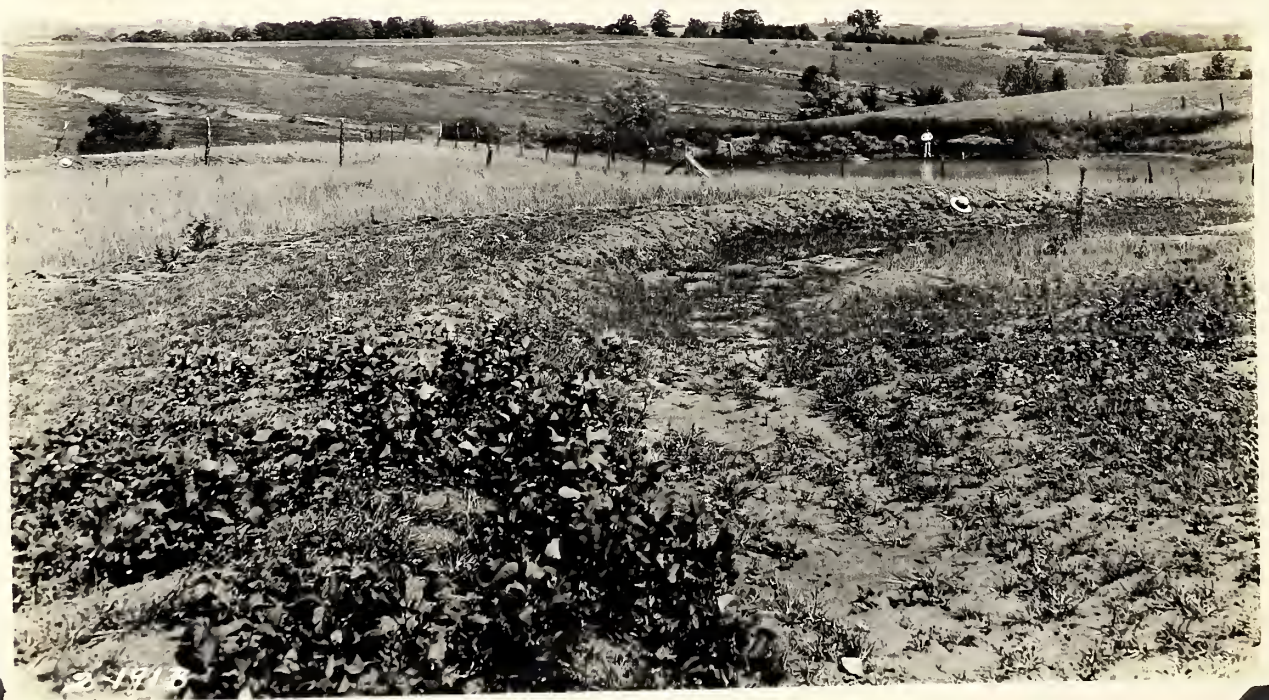
Terraces emptying into stock pond.

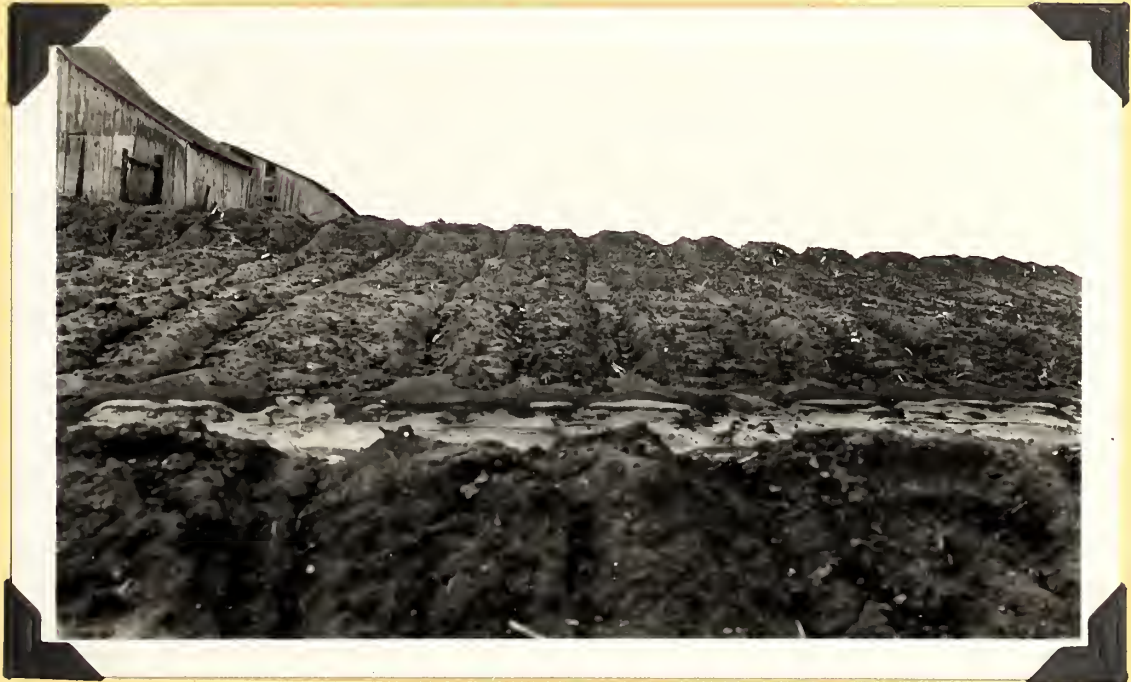
Terraces, like anything else on the farm, must be maintained.

Furrow openers run straight over terraces soon  
destroy them.

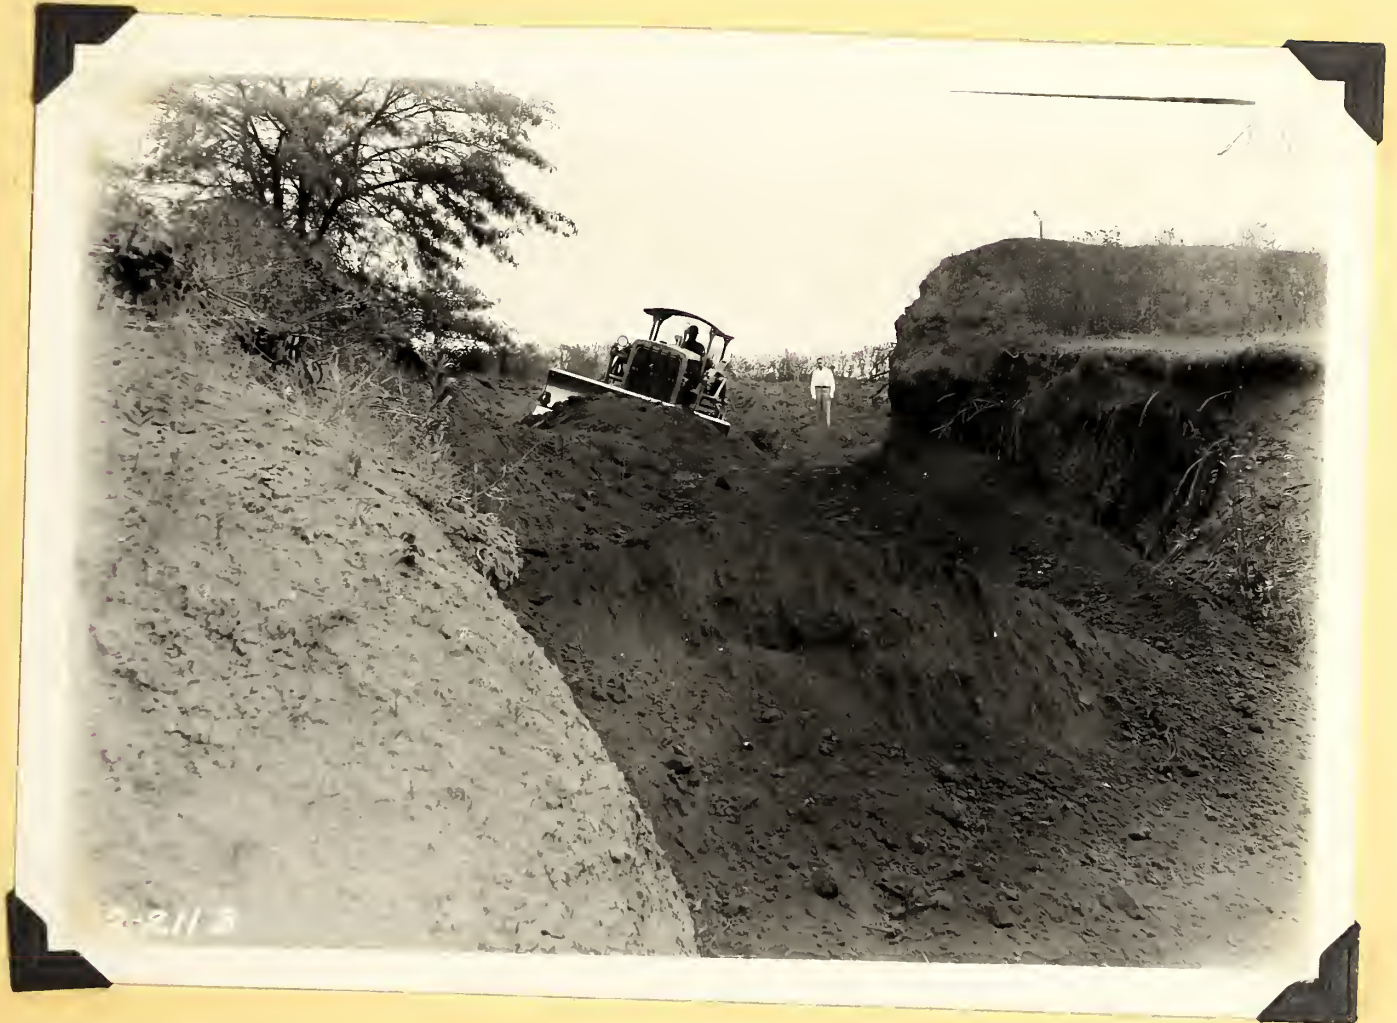
"Bulldozing" an earth dam in gully shown at left.
